Termination method for Plastic Optical Fiber

MITSUBISHI CHEMICAL CORPORATION

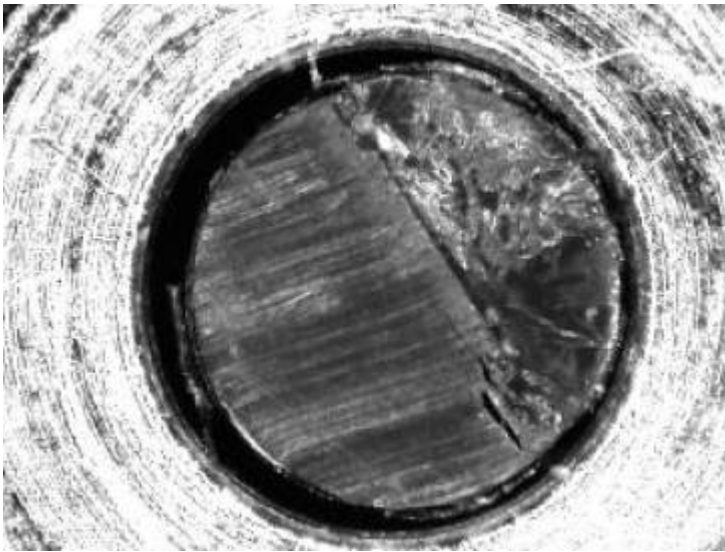
Appearance of **just cutting**

-In case of this picture, blade has entered from left side. The left side is well finished but right side is cracked. This crack occurs under the strong stress of scissors.

However you will have polish or hotplate processing at next step, it is needed to cut clearly.

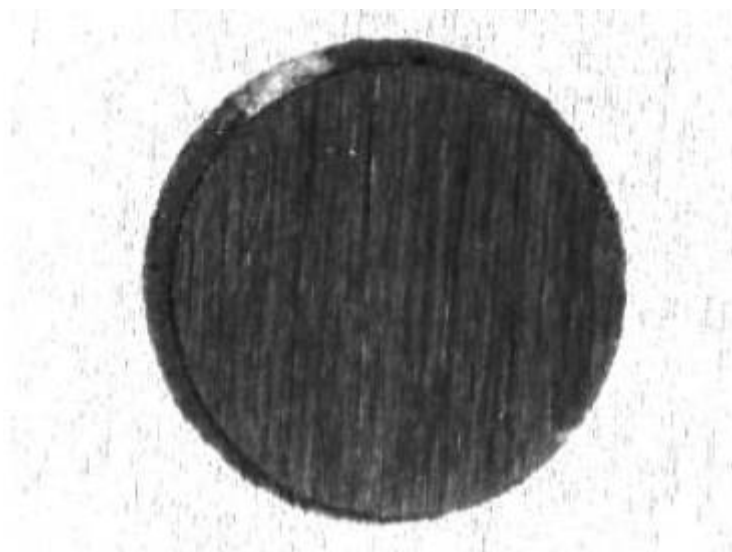
Appearance of **polished by sandpaper #800**

Sandpaper #800 is not enough. You can see from this picture that lots of scars.

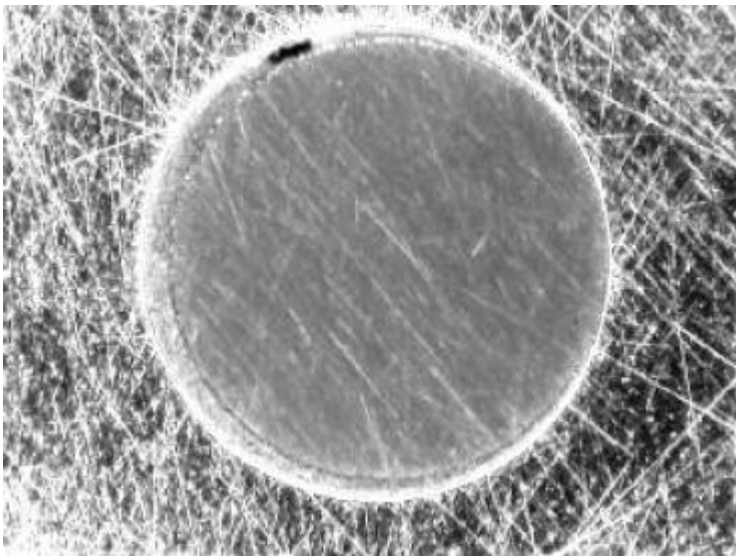
Appearance of buffing

Though you can see slight scars, those scars are very shallow and normally it is not visible. (In this picture, we use spot light to show the scars.) This level of scar has no serious effects on optical property.

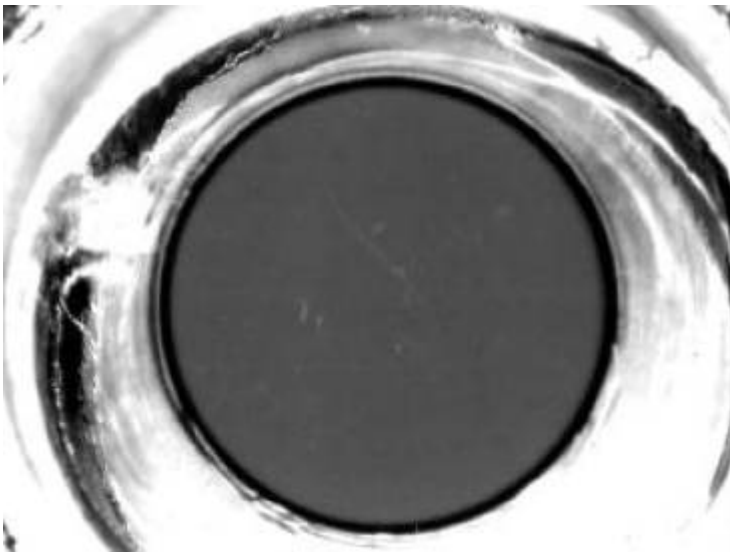
Appearance of Hotplate

You just need to put POF surface onto heated metal plate.

Metal surface will be printed to POF surface. So, metal surface has to be flat and clean.

* We do not handle hotplate equipment. So you need to make by yourself
